[Docket No. FAA-2013-0019; Directorate Identifier 2010-SW-051-AD]

Airworthiness Directives; Bell Helicopter Textron Canada Helicopters

ACTION: Notice of proposed rulemaking (NPRM).

BELL HELICOPTER TEXTRON CANADA (BHTC): Docket No. FAA-2013-0019; Directorate Identifier 2010-SW-051-AD.

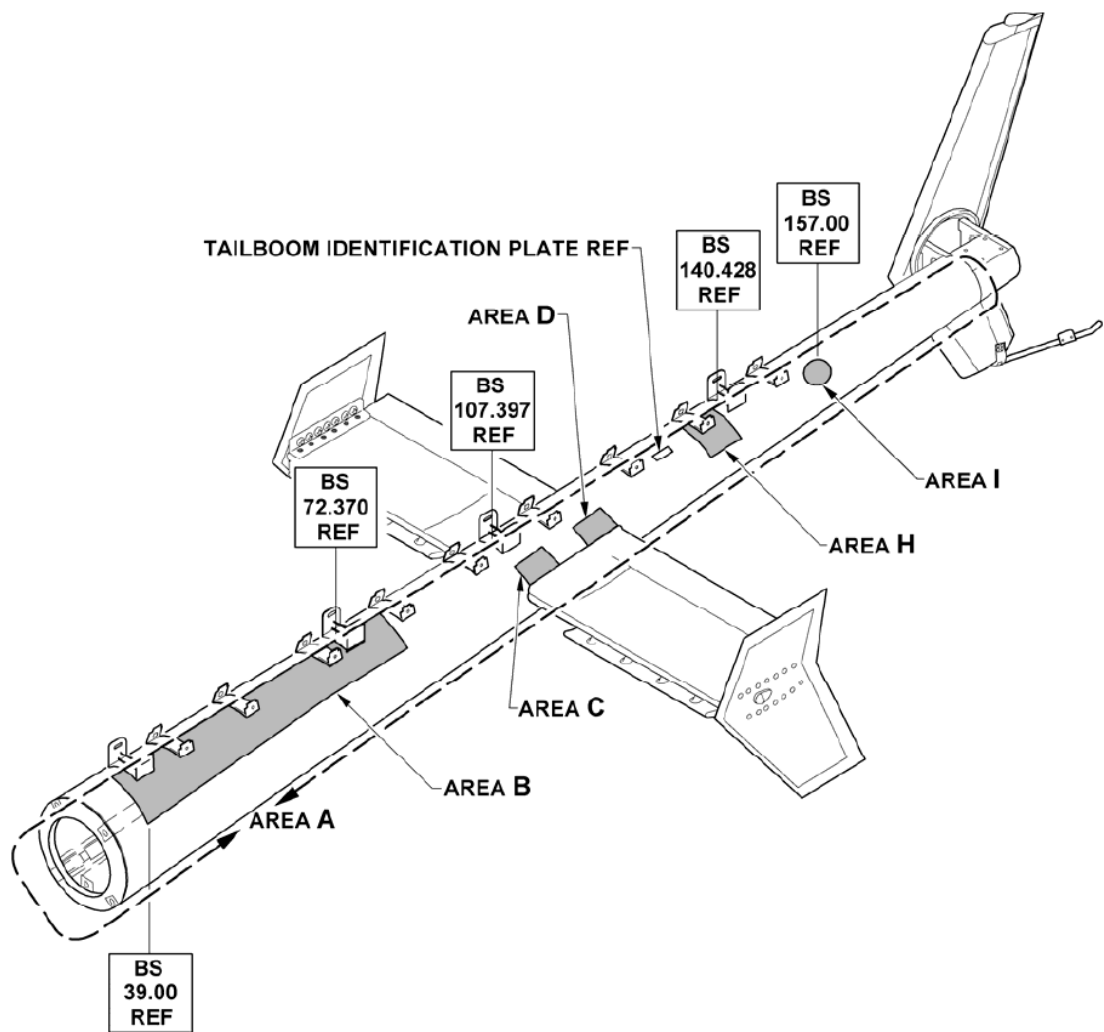
Figure 1 to Paragraph (d)

This AD defines the unsafe condition as high-stress-concentration areas in the tailboom skin that are at risk of cracking. This condition could result in a crack in the tailboom assembly, failure of the tailboom, and subsequent loss of helicopter control.

(A) Before the first flight of each day, visually check for a crack in the “C” and “D” areas depicted in Figures 1 and 2 to Paragraph (d) of this AD. The actions required by this paragraph may be performed by the owner/operator (pilot) holding at least a private pilot certificate, and must be entered into the aircraft records showing compliance with this AD in accordance with 14 CFR 43.9 (a)(1)-(4) and 14 CFR 91.417(a)(2)(v). The record must be maintained as required by 14 CFR 91.417, 121.380, or 135.439; or

(5) If there is a crack in the tailboom assembly, before further flight, replace it with an airworthy tailboom assembly.

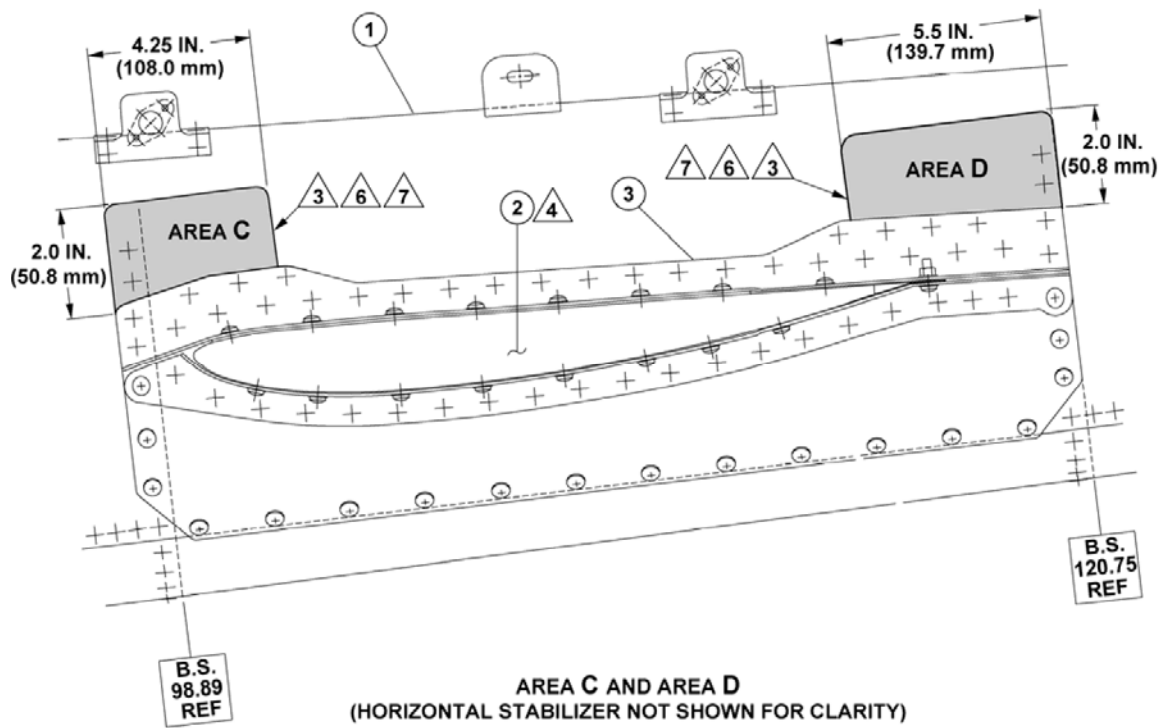
(B) Within 25 hours TIS, or 30 days, whichever comes first, and thereafter at intervals not to exceed 50 hours TIS, clean and inspect for a crack around each fastener and just above the edge of the upper stabilizer support in the “C” and “D” areas on the left side of the tailboom assembly, as depicted in Figure 2 to Paragraph (d) of this AD, using a 10X or higher power magnifying glass.
